EVALUATION OF THE FUZING SYSTEM FOR THE
MISSILE "LOON" (JB-2)

NAVORD Report 1876

12 August 1952

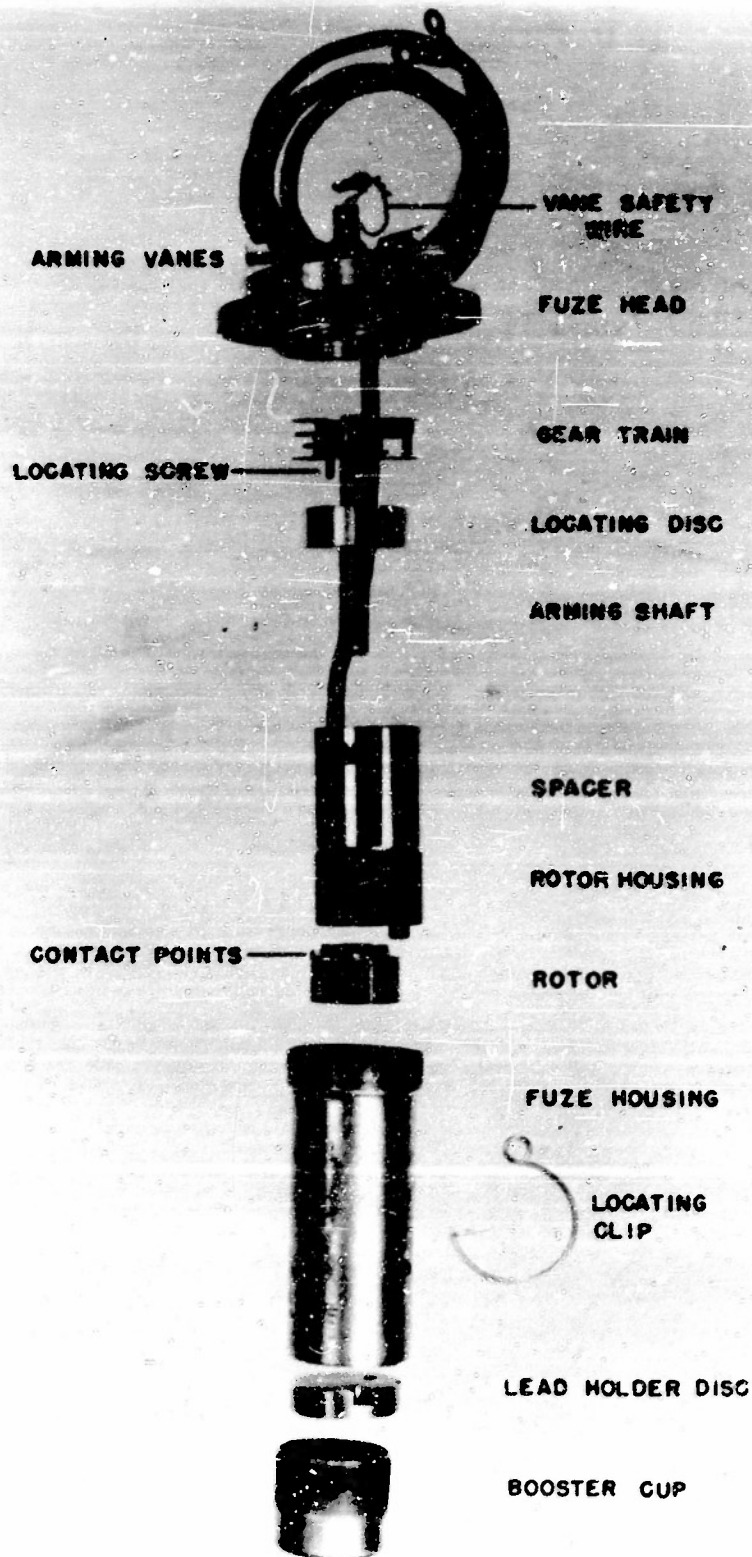
FIG. 4 T74E3 FUZE (EXPLODED VIEW)

- a. One booster cup came unsealed.
- b. One fuze sleeve came unsealed from the fuze head.
(The booster cup and fuze sleeve are sealed by using Petman cement).
- c. The small locating screw (figure 4) which holds the gear housing to the locating disc inside the spacer was loosened

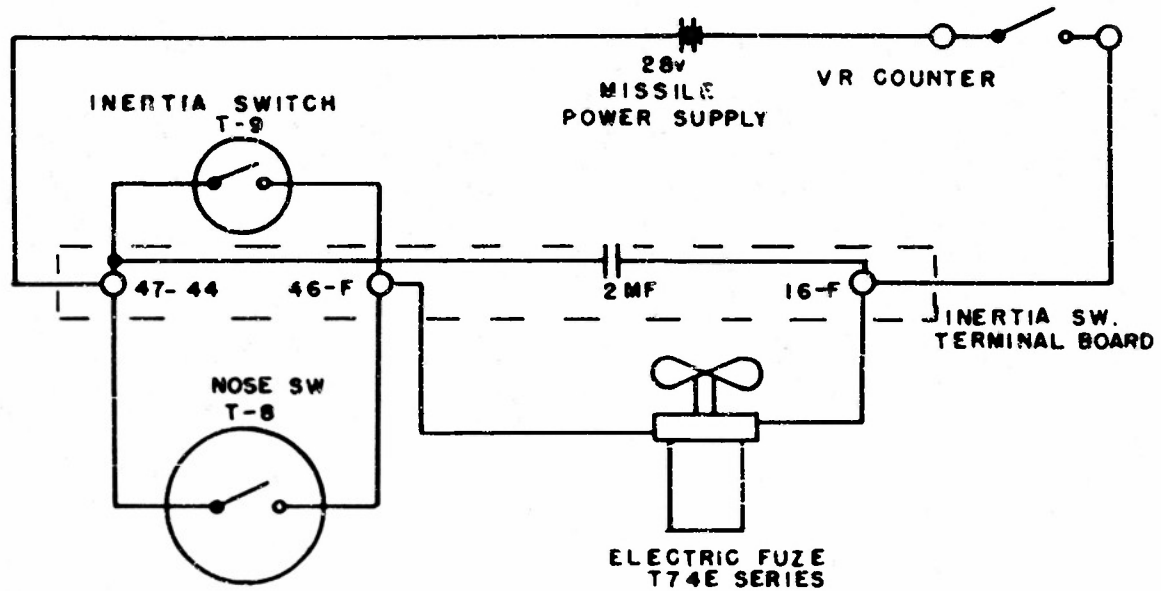
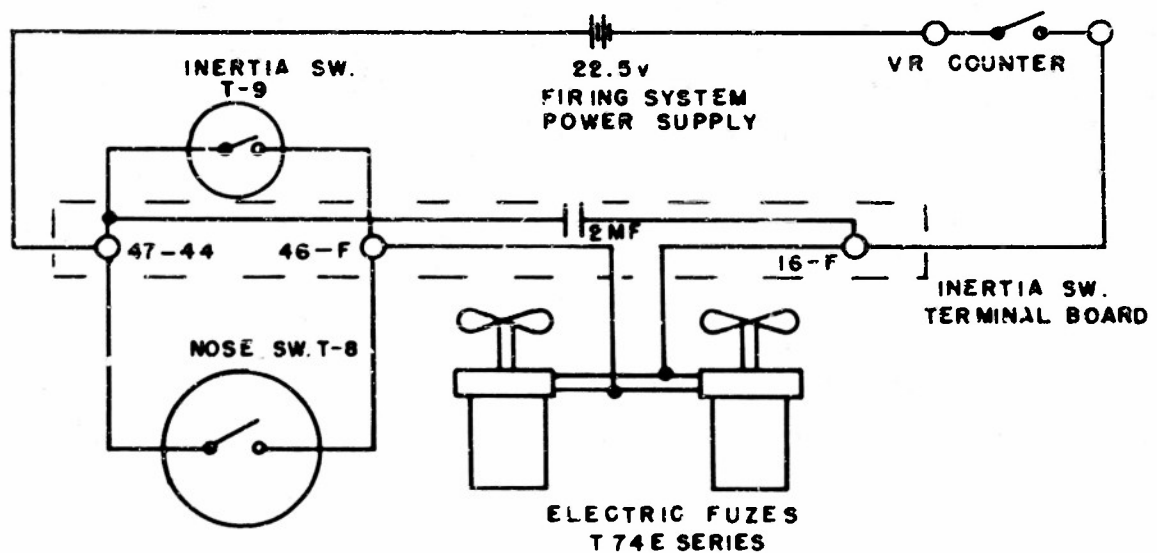
FIG. 8
DIAGRAM OF MODIFIED FIRING CIRCUIT

6. Figure 8 shows the original circuit for the electrical components of the fuzing system. As can be seen from the diagram, at least three switches must close before the electrical fuze will fire. Two of these, the Veeder-Root counter and the fuze arming switch, are safety features and are closed by air travel. After these close, the weapon is fully armed and the warhead will be exploded upon closure by impact of the nose switch and/or the inertia switch.

9. The mechanical fuze T84E series was declared unsafe for Naval use, and will be discussed in paragraph 20. As a substitute for this component, it was decided to use an additional electrical fuze of the T74E series. The T74E series and the T84E series have the same external dimensions, which allowed the substitution to be readily made. The two electrical fuzes were connected in parallel as shown in figure 8.

c. The present system of controlling the end trajectory of the missile provides for diving the entire fuselage into the target by blowing off the wings, stopping the pulse jet engine and removing the forces which control the tail surfaces so they will assume a neutral position. The trajectory of the fuselage then approximates that of a free falling bomb. One wing is blown off a fraction of a second after the other to give the fuselage an initial spin to improve the consistency of the trajectory. Previous tests by the NAMTC have shown that wing blow-off and/or the displacement of components due to spin usually result in the missile power supply battery being shorted. To prevent the live-loaded missile from becoming a dud from this cause, a separate 22.5 volt dry battery was provided as a power supply for the fuzing system. It was mounted in a special bracket on the under side of the inertia switch mounting bracket and was connected as shown in figure 8.

b. If the present method of controlling the terminal trajectory (wing blow off) is used, it is recommended that the system described in the published information (reference (b)) be changed to the system shown in figure 8. This change consists of:

(1) Replacement of the T84E series mechanical fuze with a T74E series electrical fuze connected in parallel with the original T74E series electrical fuze (the T84E series is not recommended in any case).

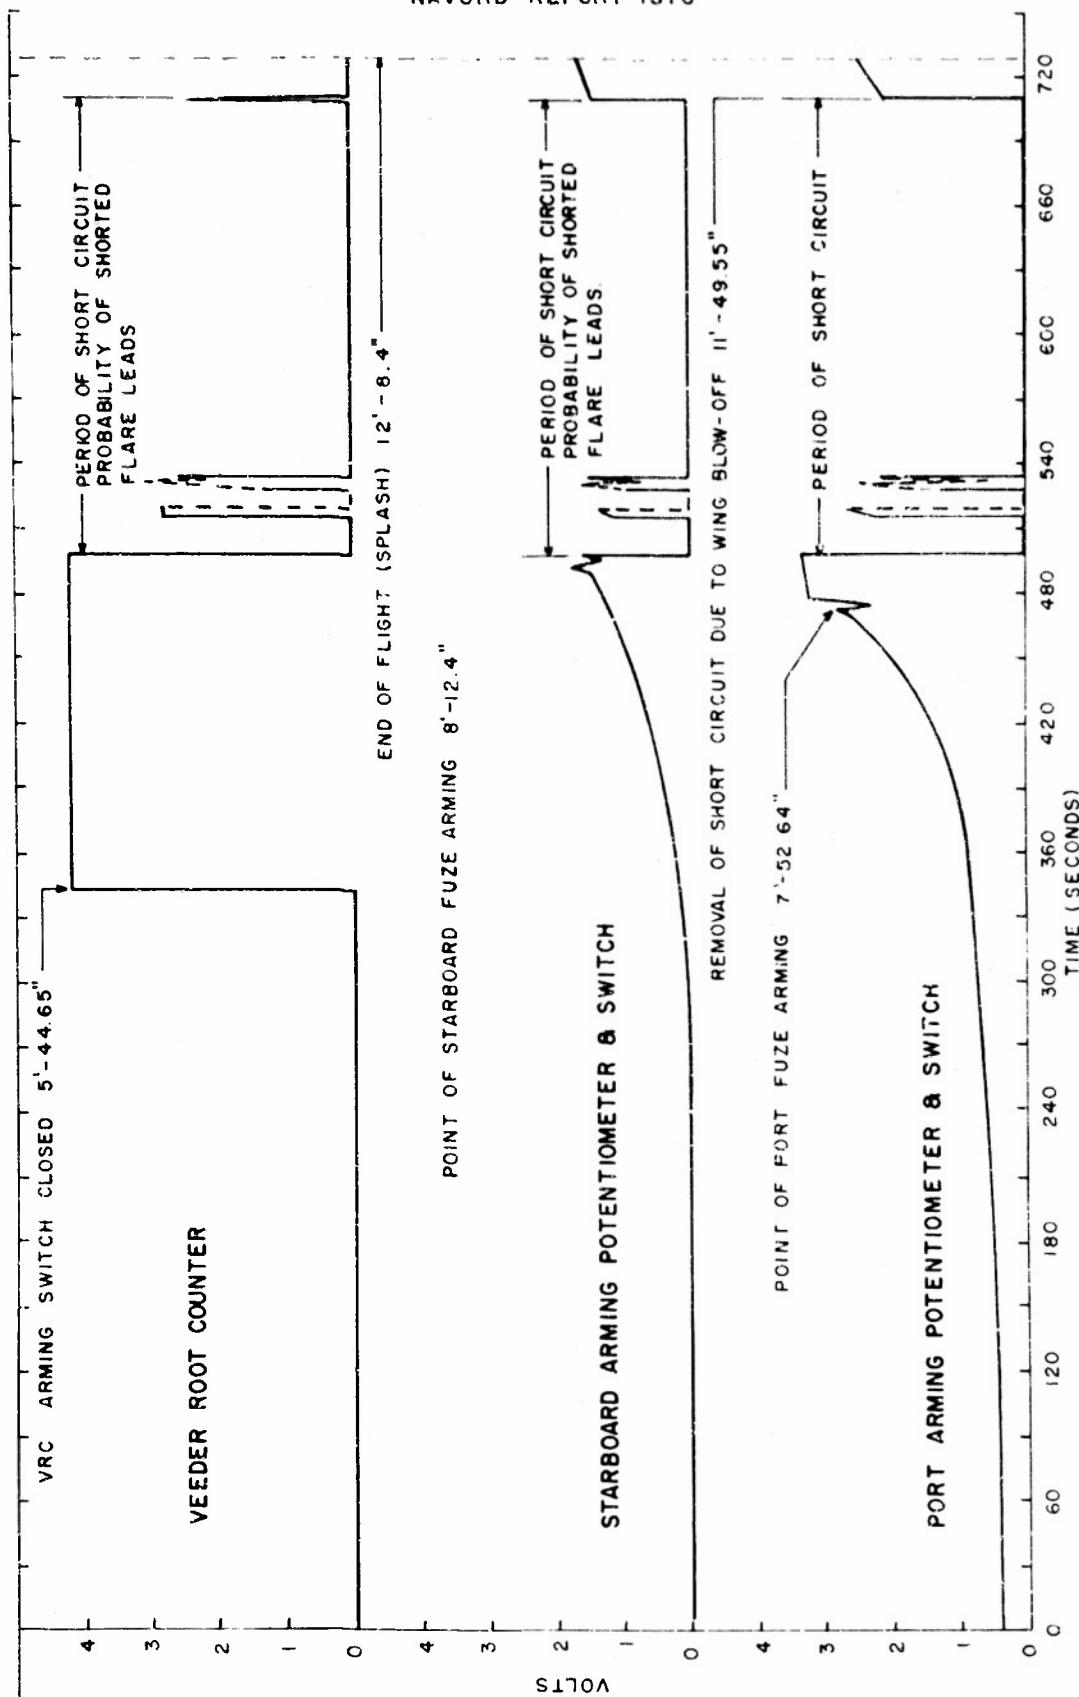
FIG. II CURVES FROM TELEMETERED FLIGHT OF 15 DECEMBER 1950

15. The second flight test was conducted on 15 December 1950 from the same launcher. The launching and flight were normal and the test was considered successful in all respects. Figure 1 is a photograph of this missile during the launching phase. Figure 11 shows the telemetered record of the Veeder-Root counter and the two fuzes, in foreshortened form. The information obtained from these curves and its interpretation is as follows:

a. The Veeder-Root counter arming switch closed 5 minutes 44.6 seconds after launching. The missile speed during its climb to its maximum altitude of 4700 feet (altitude control had been preset to 5,000 ft) averaged about 220 knots ("Indicated Air Speed", as reported by the chase plane pilots). Thus the missile had traveled approximately 24.1 air miles at V-R counter arming switch closure, which is within reasonable accuracy of the preset distance of 25.3 miles.

b. The port fuze rotor turned smoothly into the armed position, arming the fuze after 7 minutes 52.6 seconds of flight. The firing of the port wingtip smoke flare reported by the chase plane observers corresponds with the telemetered record. The distance traveled by the missile at this time was approximately 33 miles as determined by the missile tracking stations. The published information (reference (b)) gives the arming distance of the T74E3 fuze as 25 to 30 miles.

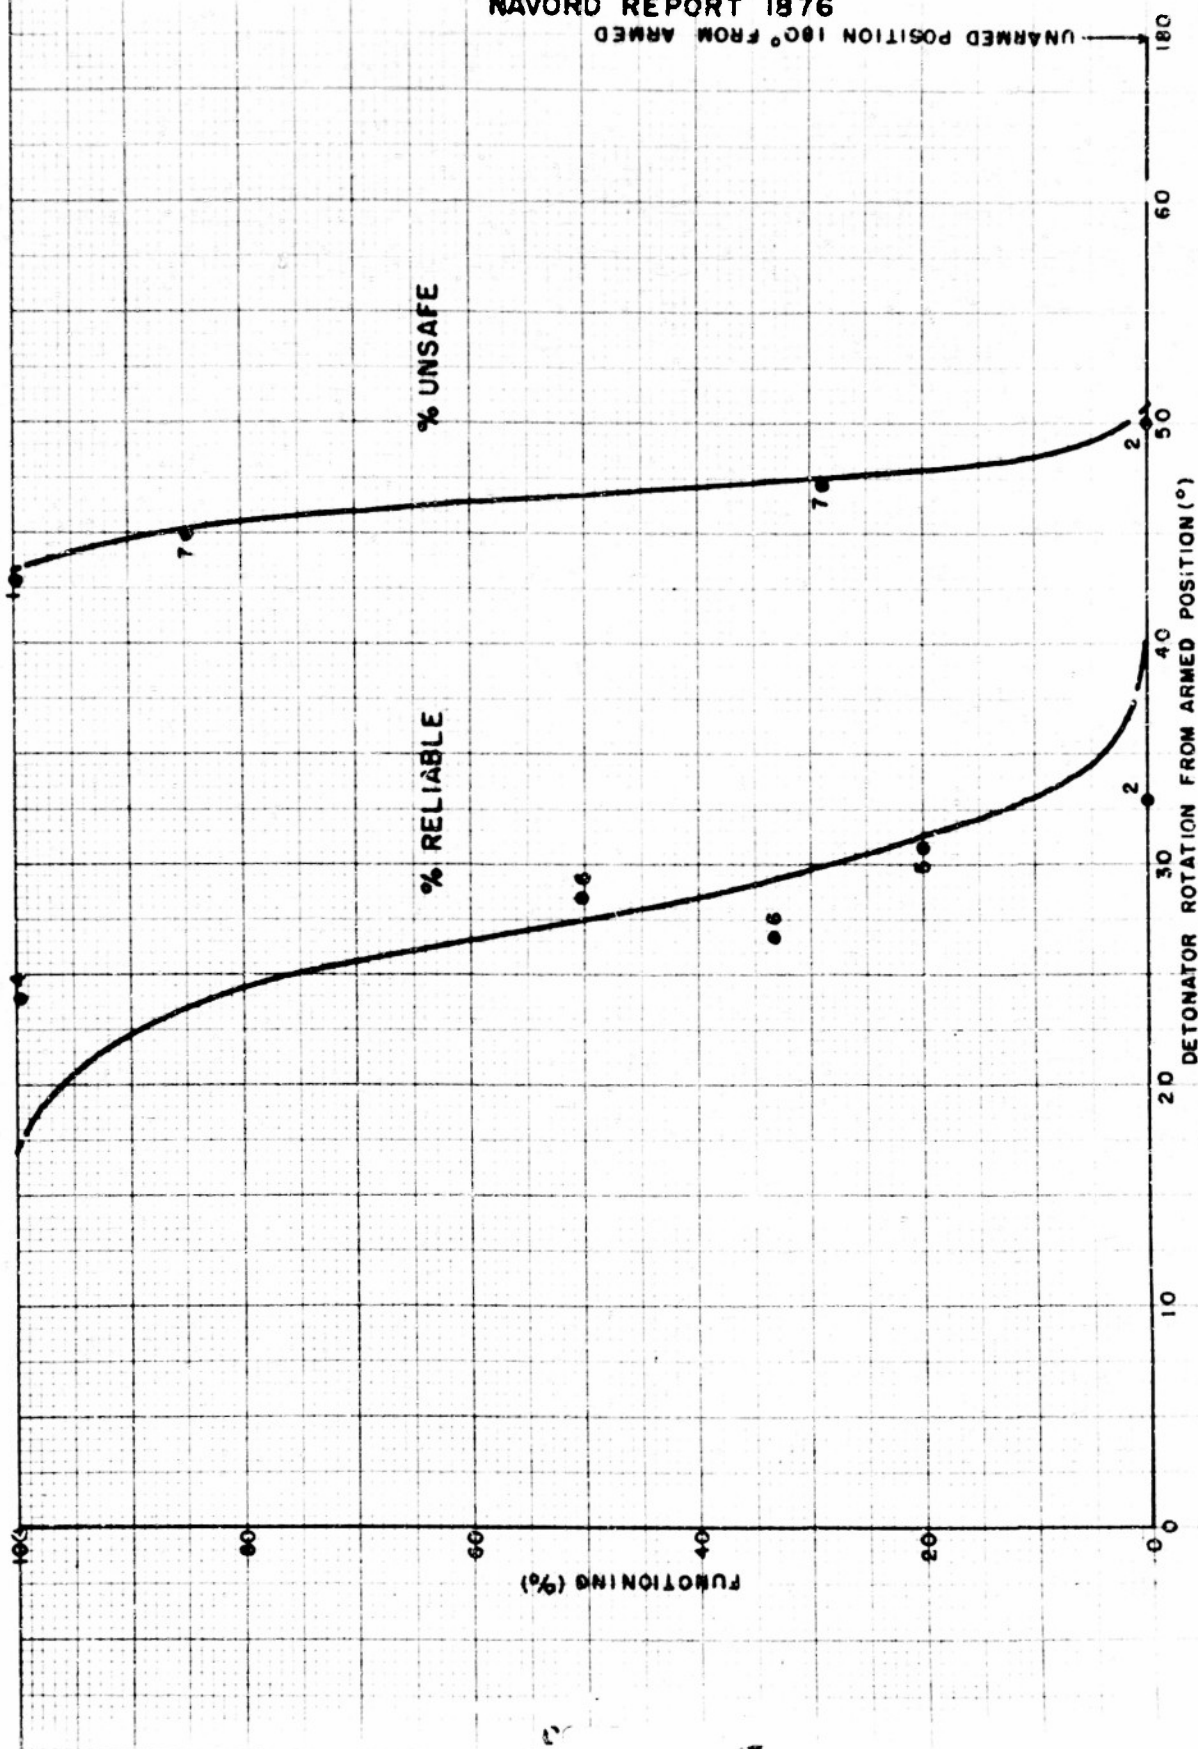
FIG.12 DETONATOR SAFETY AND RELIABILITY

however, these calculations are the best estimate that may be obtained from the data. Referring to figure 12, it is seen that the 50% points of the reliability and the unsafety curves are about 20° apart. In view of this condition, the judgment of the unsafe position does not appear to be too severe, even though there was no visible rupture of the lead cup or burning of the tetryl.

g. The 0.1% unsafe position was predicted to be 51° from armed. Since the completely unarmed position is 180° from armed, the fuze appears safe in this respect.
